Manhole Inspection Summary

Manhole # S13YY1005MH

Insp Date: **8/9/06 12:00 AM**

Location Address: **CROSS COUNTRY BLVD**

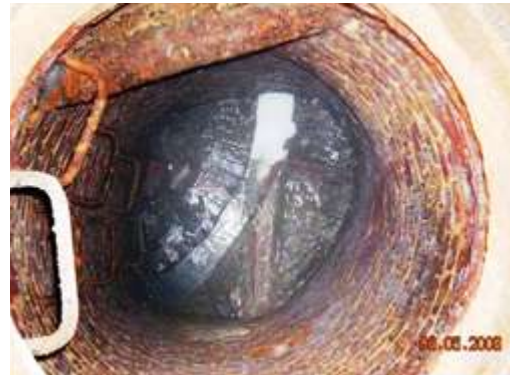
Top View

Corroded steps. Bench and Channel debris.

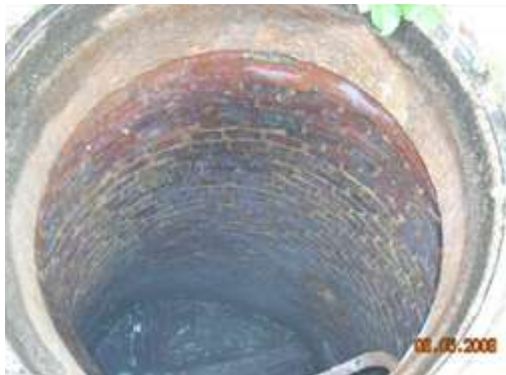
Defect

Frame leaks. Corbel deterioration and infiltration. Barrel infiltration.

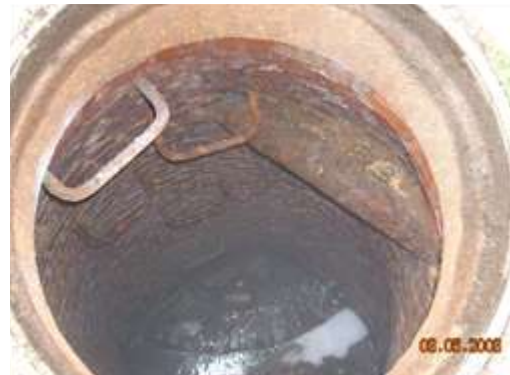
Defect

Frame leaks. Corbel deterioration and infiltration. Barrel infiltration.

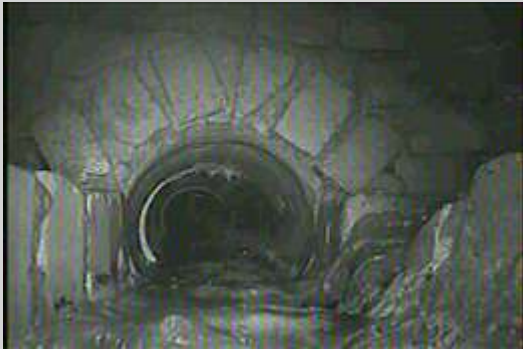
8 in. Circular Gravity Sewer Pipe Out @ 12 O'Clock

Infiltration: **Evidence** Pipe Seal Cond: **Unknown**

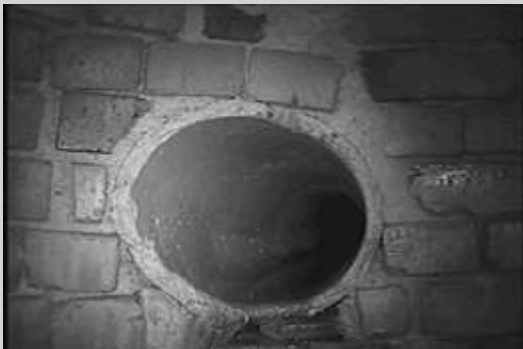
8 in. Circular Gravity Sewer Pipe In @ 2 O'Clock

Infiltration: **None** Pipe Seal Cond: **Cracked**

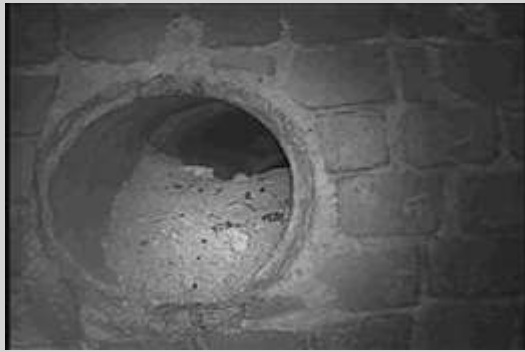
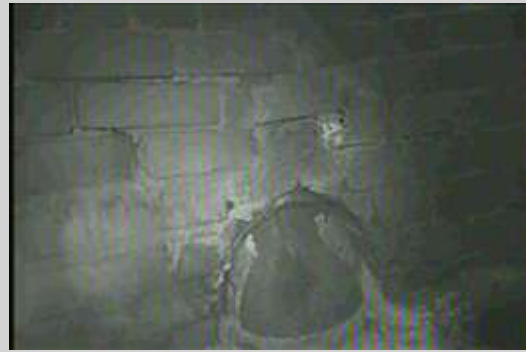
Pipe In @ 6 O'Clock

Infiltration: **Evidence** Pipe Seal Cond: **Cracked**

Drop: **Outside** Rod and Bar
Angled: **Yes** Reading: **11.16** (ft.)
Inv Depth: **12.16** (ft.)
Drop Condition: **Partly Clogged**

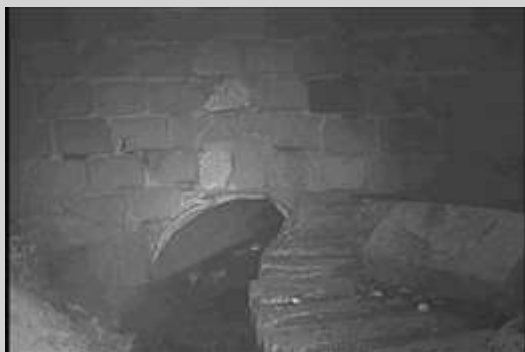
Pipe In @ 7 O'Clock

Deposits: ☐ None ☒ **Mud** ☐ Sludge ☒ **Debris** ☐ Grease

Silt Depth: **1** (in.) Deposits Extent: **Light**

Infiltration: **Evidence** Pipe Seal Cond: **Broken**
